OPERATION PLUMBBOB

NEVADA TEST SITE
MAY-OCTOBER 1957

Project 30.7

TEST OF GERMAN UNDERGROUND
PERSONNEL SHELTERS

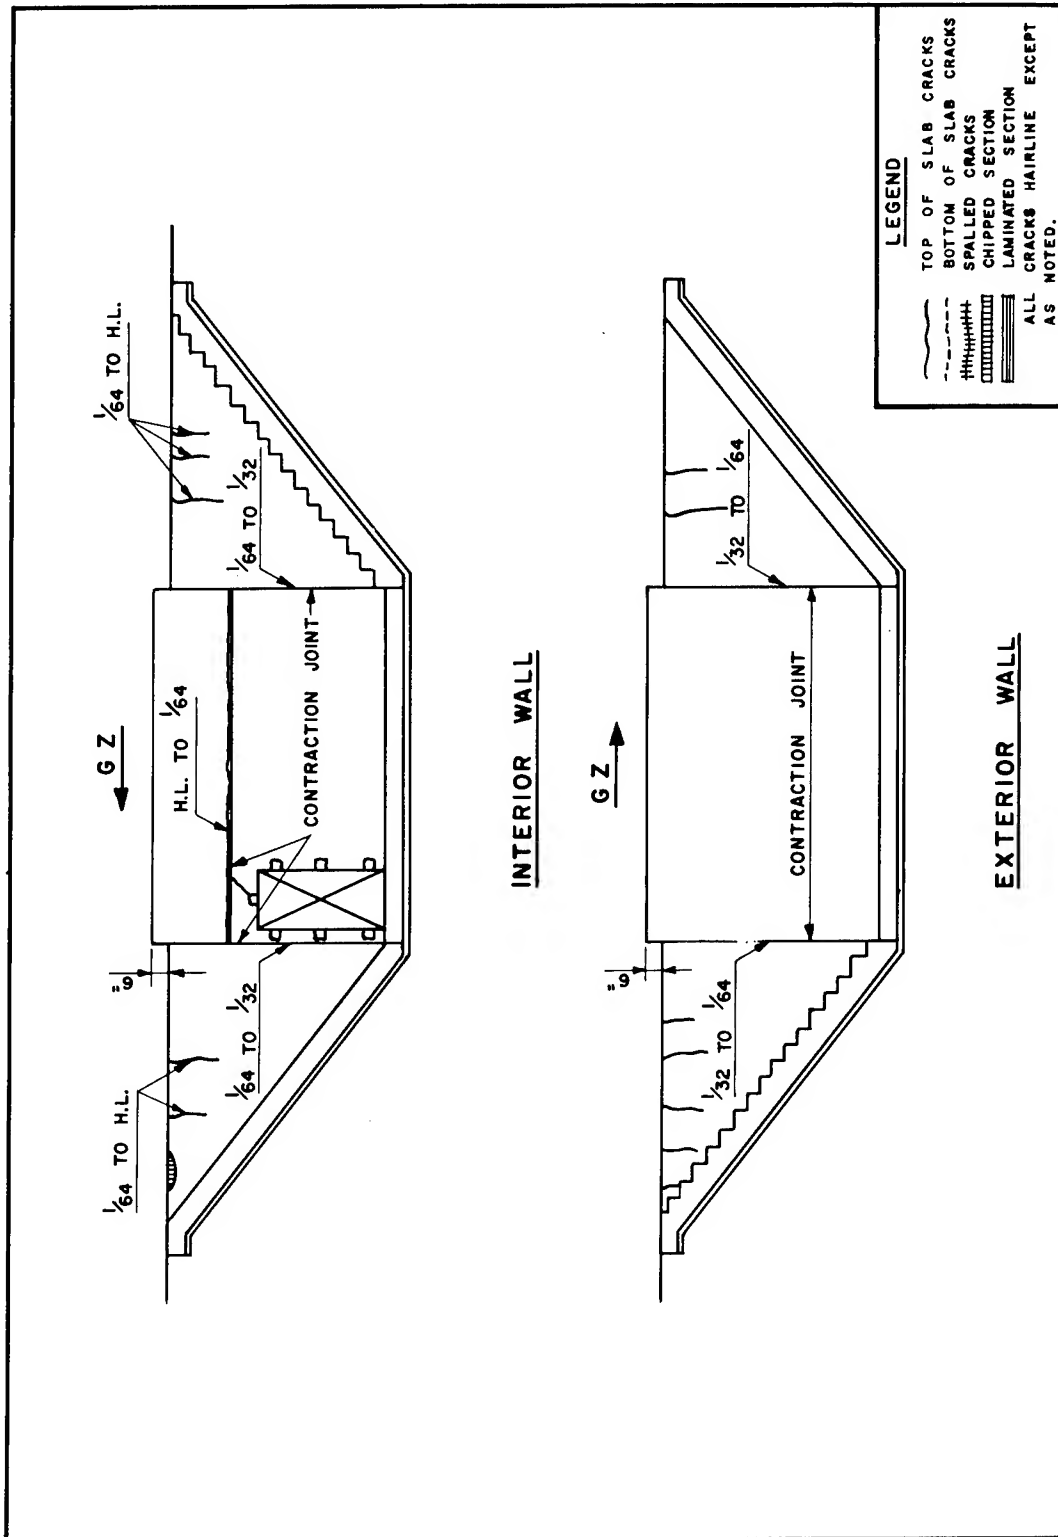
Fig. 3.94—Entrance crack pattern (structure RCb).

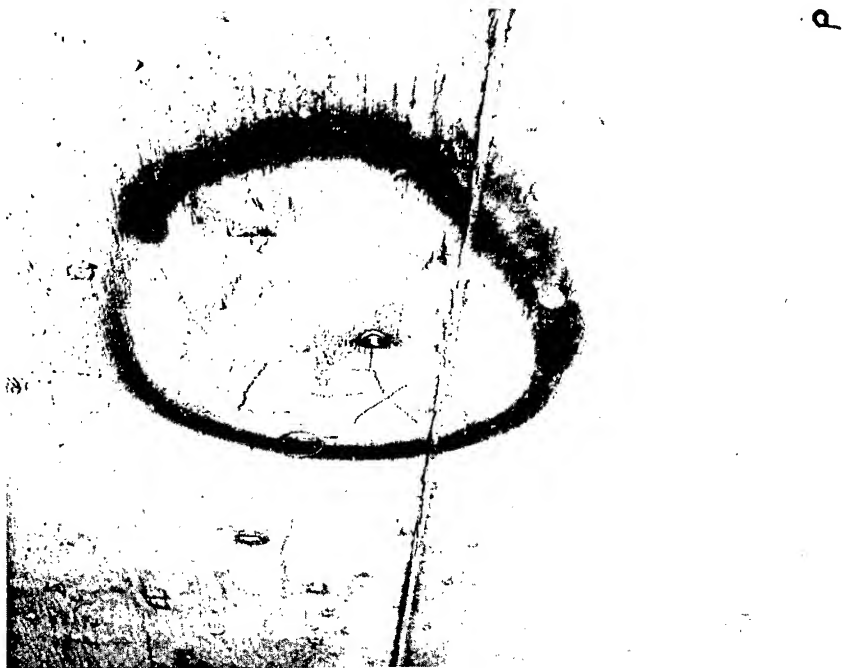
Fig. 3.96—Cracks by center of roof slab (structure RCb). Note survey point X-7.

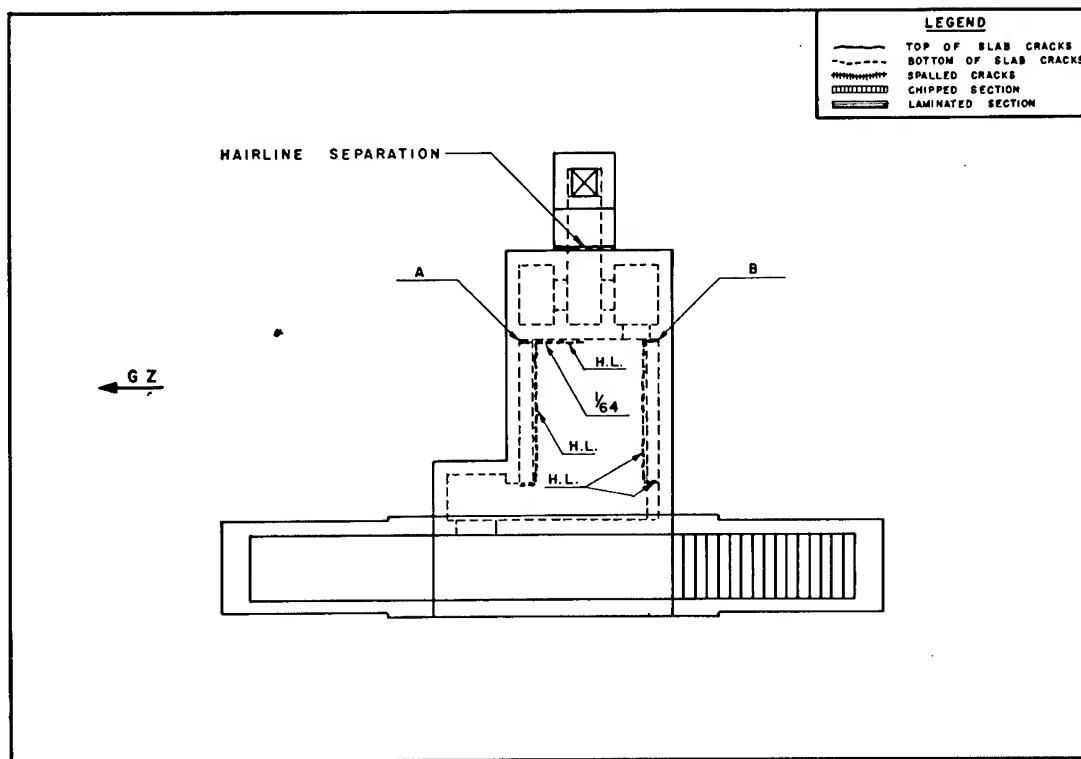
Fig. 3.99—Roof-slab crack pattern (structure RCc).

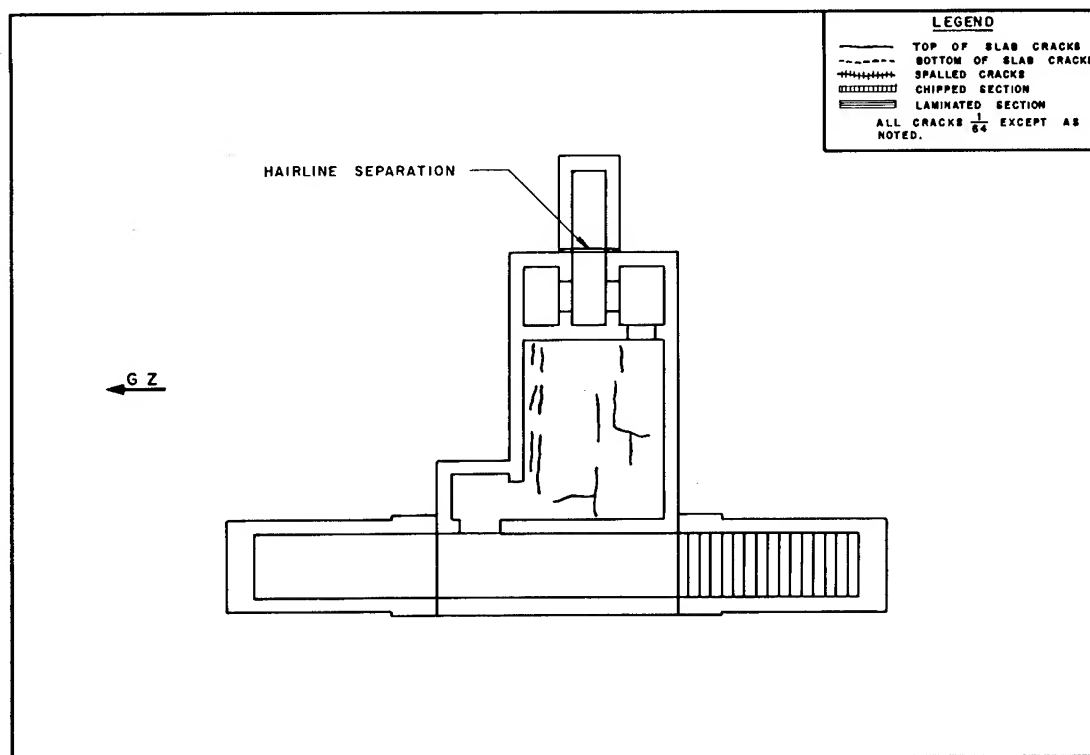
Fig. 3.100—Floor-slab crack pattern (structure RCc).

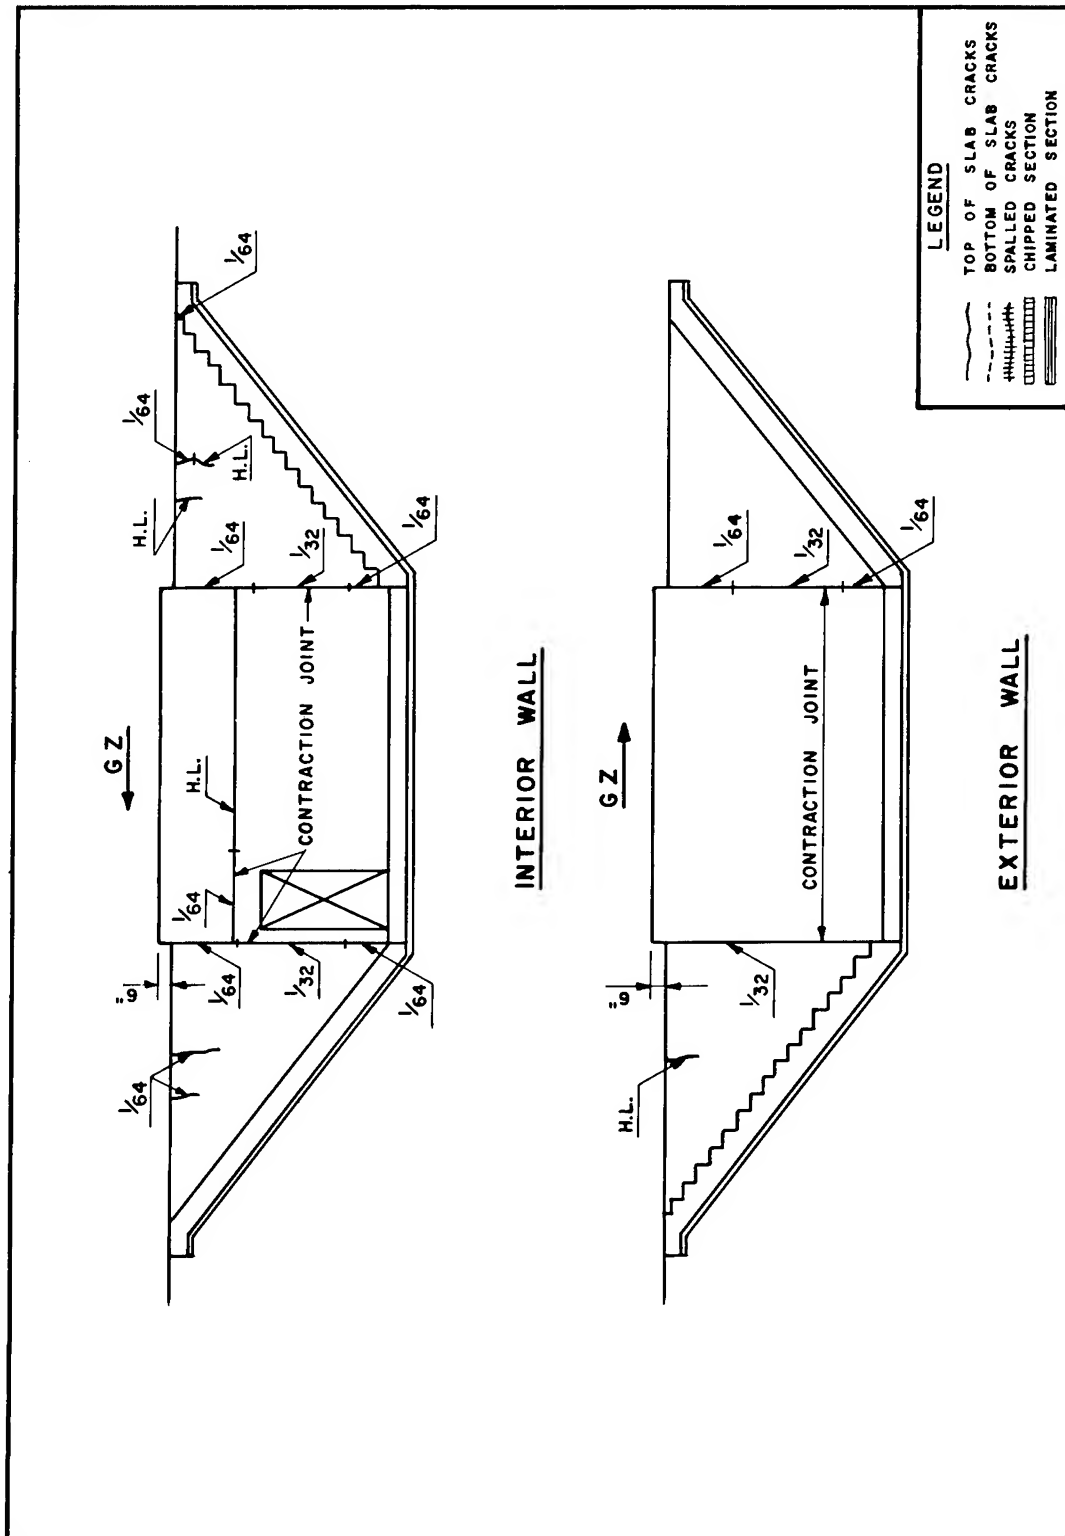
Fig. 3.101—Entrance crack pattern (structure RCc).
